Grain quality analysis

Lantmännen Cerealia Oat Mill in Sweden boosts its quality analysis with 'easy-to-use' image analyser

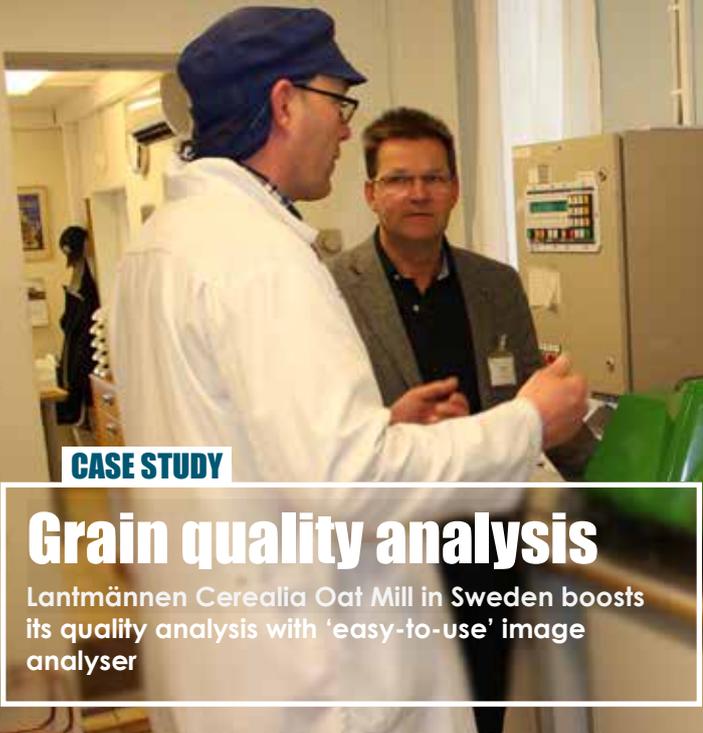
Unique patented design enables full surface analysis of every kernel

The instrument has a patented design with mirrors that enables almost the entire surface of every kernel to be analysed. This is especially important when looking for defects that might only be visible on part of the kernel and gives the analysis a very high repeatability.

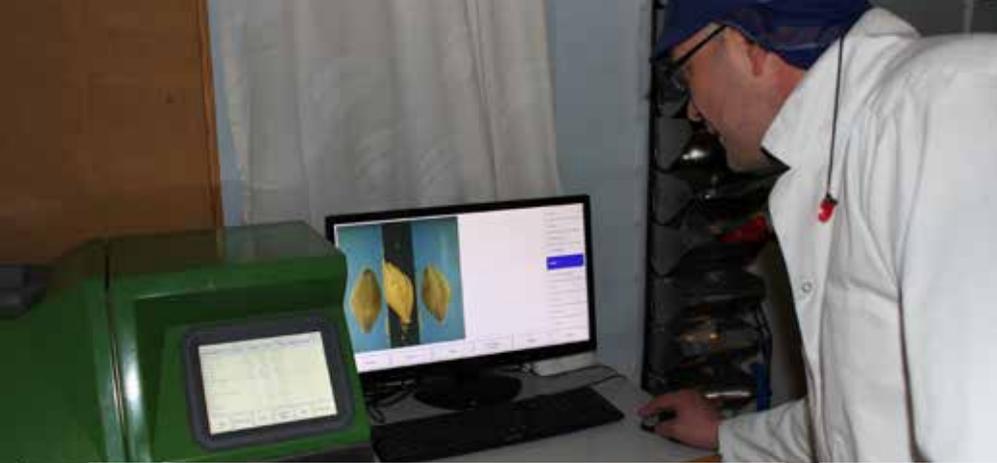
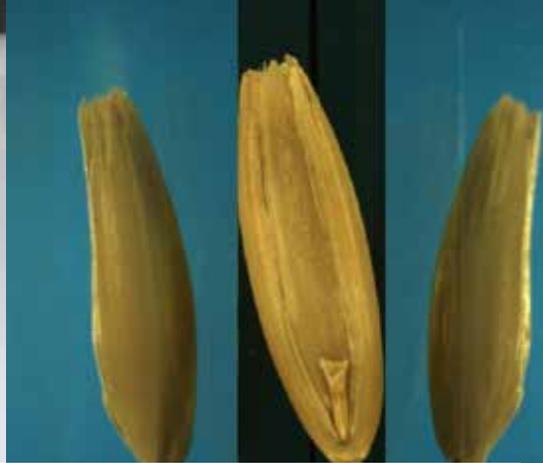
Reference: Seed Count: Weight:

| Filtered As | Count | wt% | TKW | | |
| Sieving >2.0 | | 98.66 | 42.24 | | |
| Oats | 11999 | 98.54 | 41.06 | | |
| Naked Oats | 23 | 0.16 | 35.34 | | |
| Foreign | 62 | 0.45 | 36 | | |
| Other | 142 | 0.85 | 29.86 | | |

Installation of the instrument at Lantmännen's oat mill in Sweden took place in the fall of 2016. Here the focus has been on the assessment of foreign cereals, as well as sieving analysis. Even peeled oats are determined in oats. Additionally, there are applications for finding oats with hull left in oats after peeling.
